### Western Run Pilot Project - Baltimore Maryland

### SMOKE TESTING OBSERVATION SUMMARY

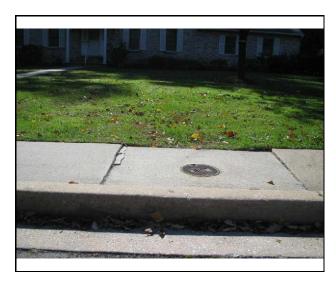
Photo No: 559

**Defect No:** 3 **Setup No:** 2 **Priority CCTV:**

**Source Type:** 02= Service Line **Location:** 5=Sidewalk **Severity:** 2=Trace

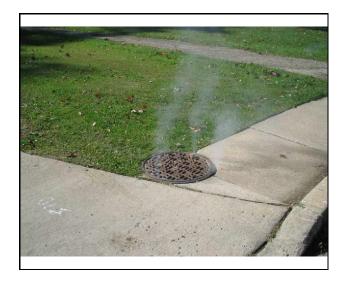
Photo No: 561

Defect No: 4 Setup No: 2 Priority CCTV:

**Source Type:** 12= MH Frame Seal **Location:** 5=Sidewalk **Severity:** 4=Major

Comments: MH 01521239

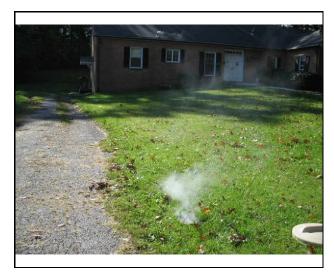
Photo No: 560

Defect No: 5 Setup No: 2 Priority CCTV:

**Source Type:** 04= Cleanout **Location:** 7=Yard-Front **Severity:** 4=Major

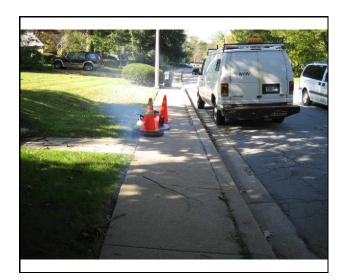
Photo No: 562

Defect No: 6 Setup No: 2 Priority CCTV:

**Source Type:** 12= MH Frame Seal **Location:** 5=Sidewalk **Severity:** 4=Major

Comments: MH 01521237

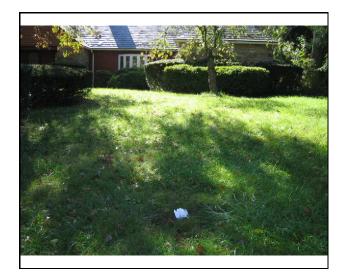
Photo No: 563

**Defect No:** 7 **Setup No:** 2 **Priority CCTV:**

**Source Type:** 02= Service Line **Location:** 7=Yard-Front **Severity:** 3=Moderate

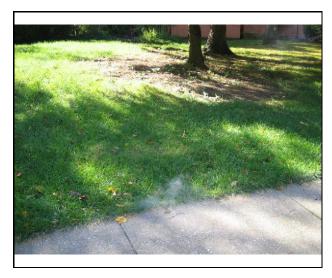
Photo No: 564

Defect No: 8 Setup No: 2 Priority CCTV:

**Source Type:** 02= Service Line **Location:** 5=Sidewalk **Severity:** 4=Major

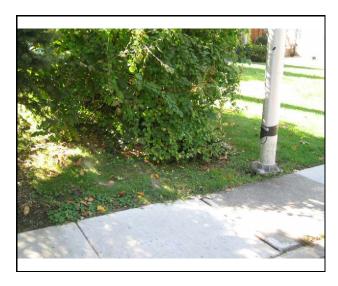
Photo No: 565

Defect No: <sup>9</sup> Setup No: <sup>2</sup> Priority CCTV:

**Source Type:** 02= Service Line **Location:** 5=Sidewalk **Severity:** 3=Moderate

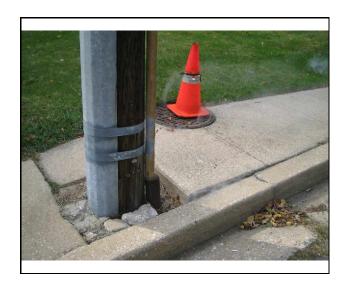
Photo No: 567

**Defect No:** 1 **Setup No:** 3 **Priority CCTV:**

**Source Type:** 12= MH Frame Seal **Location:** 5=Sidewalk **Severity:** 3=Moderate

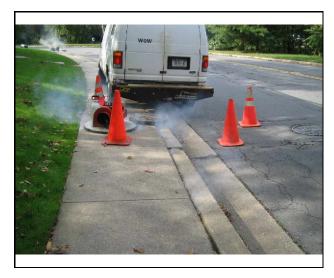
Photo No: 574

**Defect No:** 10 **Setup No:** 3 **Priority CCTV:**

**Source Type:** 12= MH Frame Seal **Location:** 5=Sidewalk **Severity:** 4=Major

**Comments:** MH 01522219

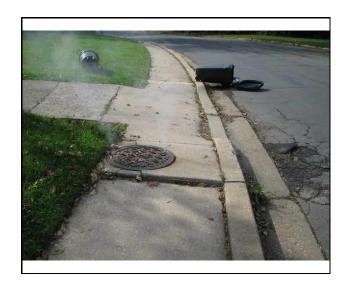
Photo No: 575

**Defect No:** 11 **Setup No:** 3 **Priority CCTV:**

**Source Type:** 12= MH Frame Seal **Location:** 5=Sidewalk **Severity:** 4=Major

**Comments:** MH 01522035

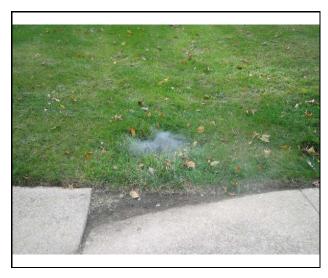
Photo No: 568

**Defect No:** 2 **Setup No:** 3 **Priority CCTV:**

**Source Type:** 02= Service Line **Location:** 5=Sidewalk **Severity:** 4=Major

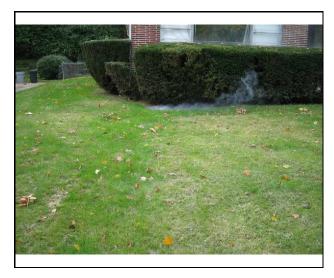
Photo No: 569

Defect No: 3 Setup No: 3 Priority CCTV:

**Source Type:** 02= Service Line **Location:** 7=Yard-Front **Severity:** 4=Major

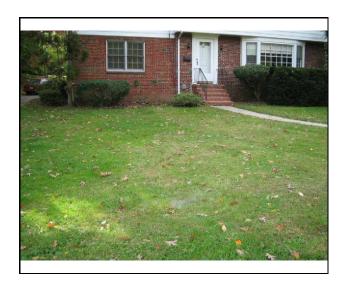
Photo No: 570

Defect No: 5 Setup No: 3 Priority CCTV:

**Source Type:** 02= Service Line **Location:** 7=Yard-Front **Severity:** 3=Moderate

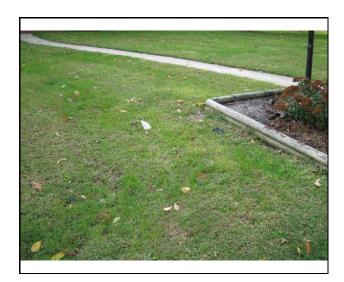
Photo No: 571

**Defect No:** 6 **Setup No:** 3 **Priority CCTV:**

**Source Type:** 02= Service Line **Location:** 7=Yard-Front **Severity:** 2=Trace

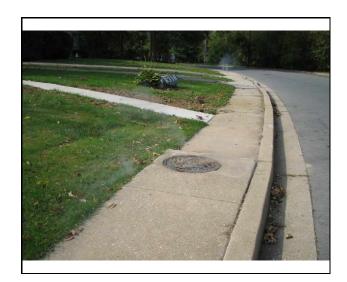
Photo No: 572

Defect No: <sup>7</sup> Setup No: <sup>3</sup> Priority CCTV:

**Source Type:** 12= MH Frame Seal **Location:** 5=Sidewalk **Severity:** 4=Major

**Comments:** MH 01522215

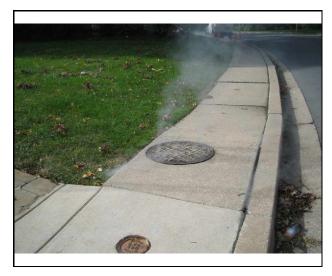
Photo No: 573

328 10/18/2004 01\_WR06 **Unique Test ID** Date: MeterBasin: В T-2 N **Observer ID:** Crew: **Dve Test Recommended:** 3 8 **Defect No: Setup No: Priority CCTV:**

**Source Type:** 12= MH Frame Seal **Location:** 5=Sidewalk **Severity:** 4=Major

Comments: MH 01522217

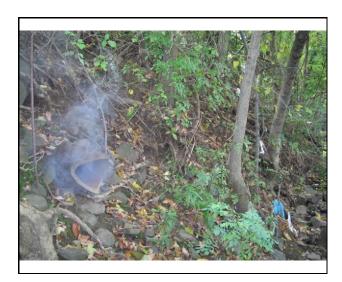
Defect No: 1 Setup No: 4 Priority CCTV:

Comments: unknown drainage
